# **Diebold TSx Evaluation**

## **SECURITY ALERT: May 22, 2006** **Supplemental report, additional observations** **Unredacted on July 2, 2006 by Black Box Voting**

A Black Box Voting Project  
Prepared by: Harri Hursti

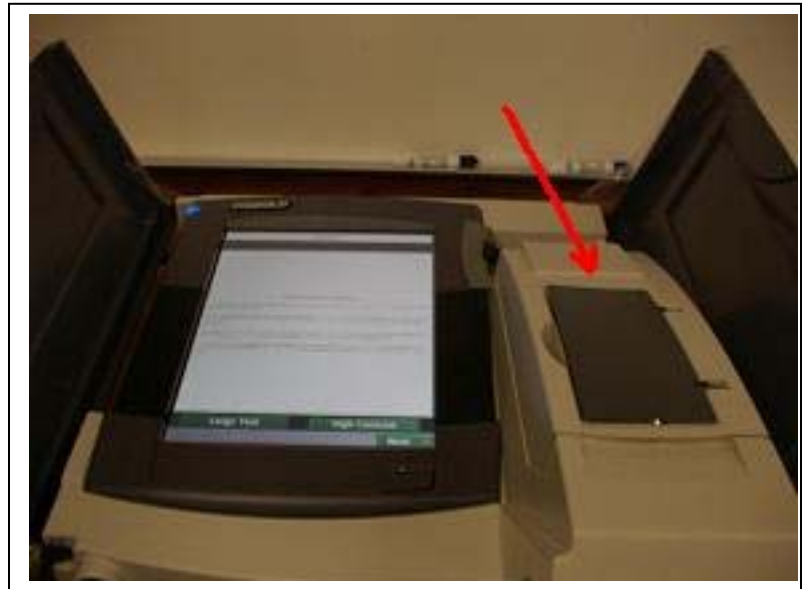
In addition, a design decision to place a brown door over the paper which the voter is supposed to verify leads to questions about the usefulness of the VVPAT. Unless the door is

lifted up it obstructs view of the paper representation of the voter's vote. If the system is to be used to verify a paper trail, it should have instructions printed prominently on the casing instructing voters to lift the brown door to see the paper trail.

Fig. 13 – Brown door blocking view of voter verifiable paper trail

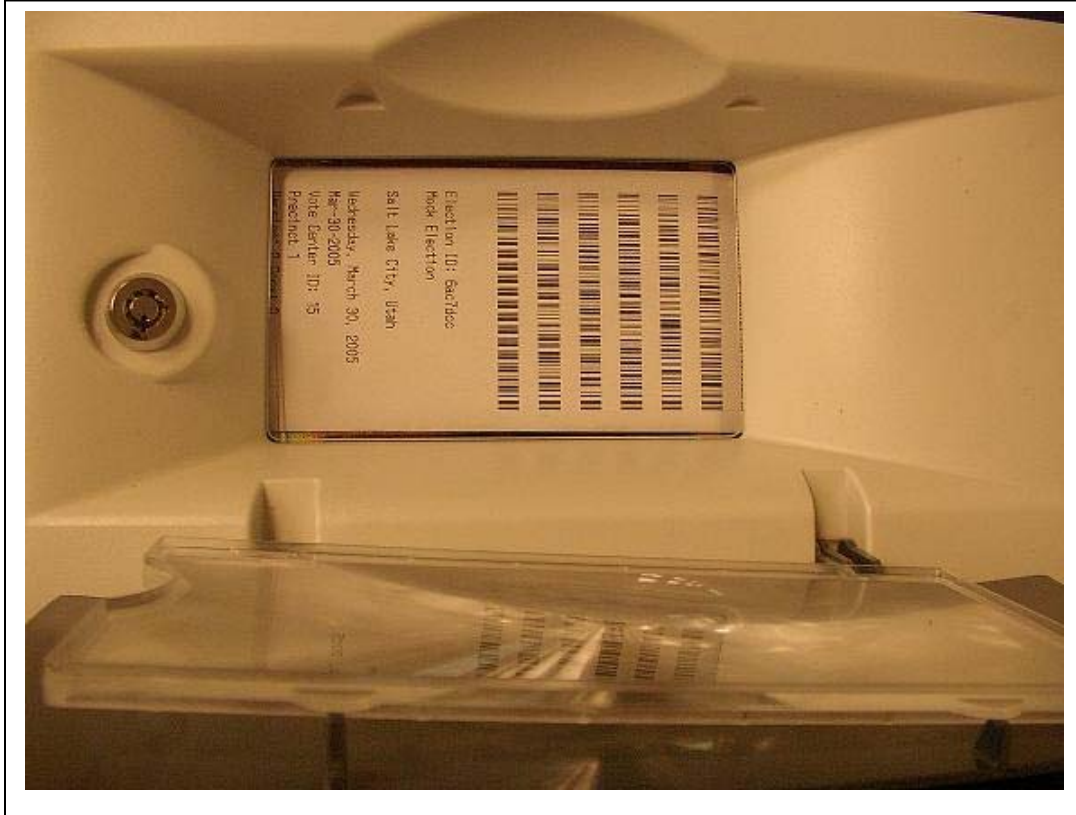
The voter can lift the lens, but the print is very small and the bottom of the paper record of the vote does not display fully.

Fig. 15 – Print is small; lower part of paper trail tends not to scroll up into full view.
