Diebold TSx Evaluation

SECURITY ALERT: May 22, 2006
Supplemental report, additional observations
Unredacted on July 2, 2006 by Black Box Voting

A Black Box Voting Project
Prepared by: Harri Hursti

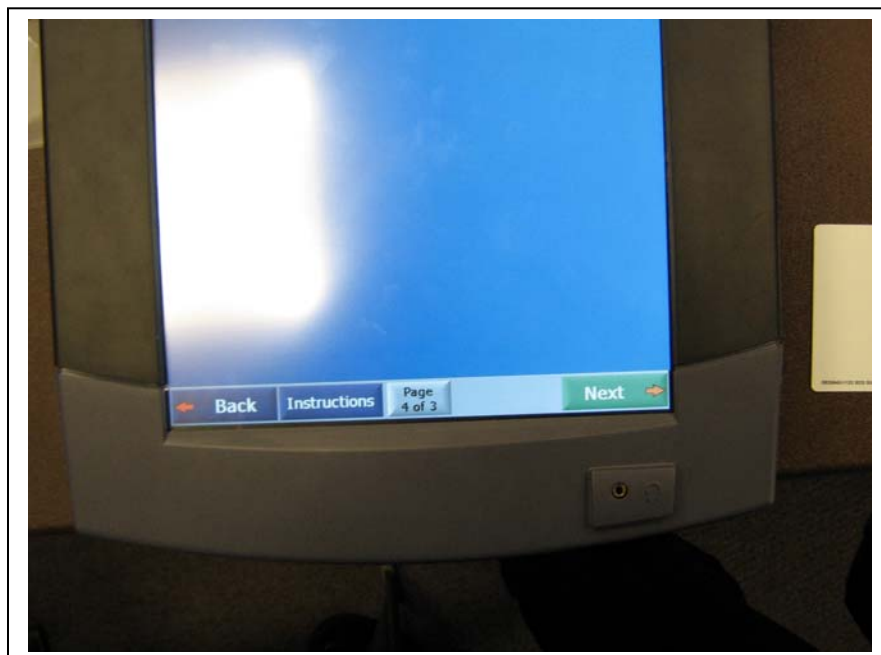
On the preliminary testing following issues were identified :
- macro is not contained in the user interface logic. Because of this macro can access settings changing the telephone number / ip address and initiate call
- Two machines, with completely identical software release numbers had different behavior with the same macro. Machine A just had a software crash and become unstable, while machine B produced an error message on the system log and contained the error while still ending to experience loss of software functionalities. There were other examples of different, but reproducible, software behaviors between machines with both modified and unmodified macros.

- File handle processing seems to be flawed and interrupted by exception macro processing produced open file handles
- There seems to be user interface race conditions, which can not be triggered by human interaction with the machine, but are revealed by no delay playback of the human actions

Fig. 8 – Macro skips to "Page 4 of 3" of 3 page ballot and
stops without error message while macro is still active

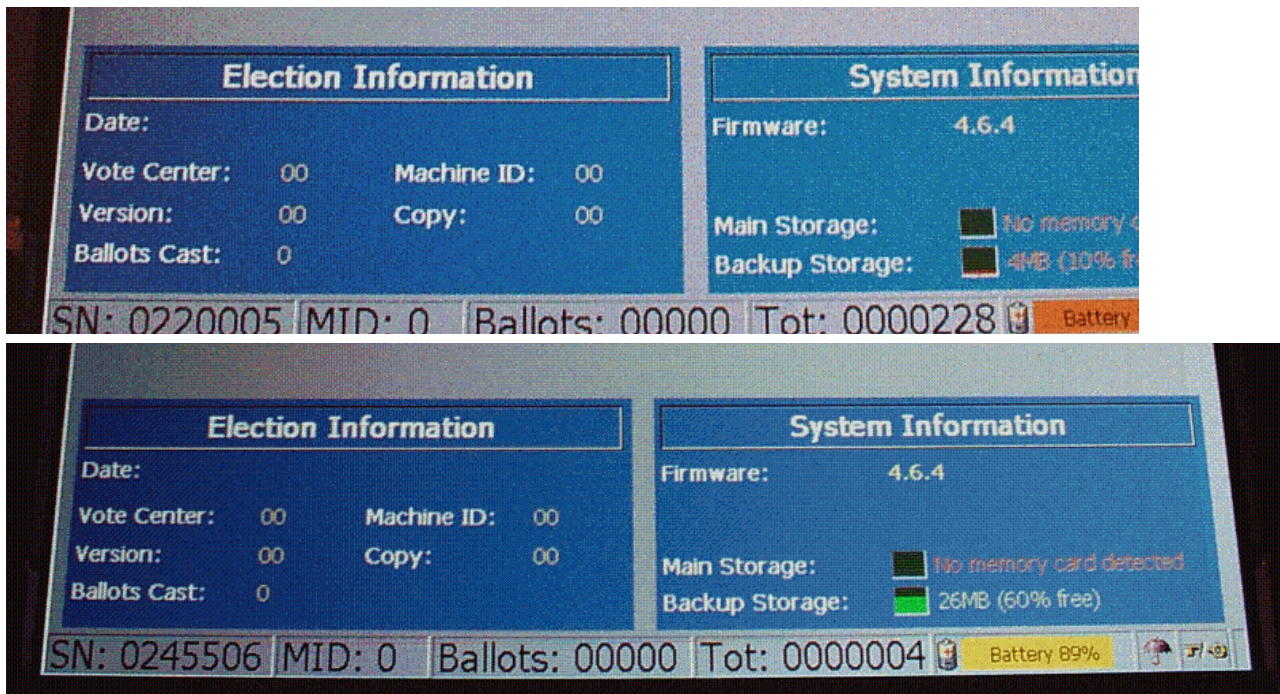
Emery County Clerk Bruce Funk noticed that some of his machines, which were marked with a yellow stick-on dot and had serial numbers in the 201000-223000 range, had screen messages indicating critically low available memory storage at the time of the delivery. Whereas machines in the 230000-255000 range had memory storage of 22-27 MB, the machines in the earlier serial number blocks had memory storage of 4-8 MB.

It was noted during this study that some machines contained test election data. Deleting this data did not free up a significant amount of memory. After this study, Diebold has explained that this lack of memory is due to the presence of extra fonts installed on some machines. No study was done to find out the reason for varying free memory sizes.

Fig. 9 – Serial numbers: Variations in memory storage available

Fig. 10 – Screen shots: Variations in memory storage available

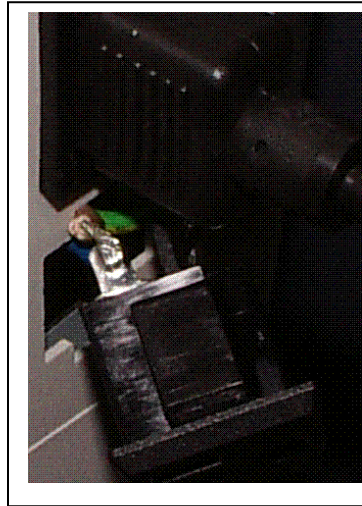
The electrical sockets on the TSx are not properly fitted to the case. Every unit examined
revealed problems with sockets popping out or falling out, sometimes by simply moving the
machine or through light contact with the cord. Because many polling places lack sufficient
wall outlets to plug in all the machines, these machines are typically daisy-chained together

(one machine plugged to the next) with a single machine plugged in to the wall. The improperly designed socket design presents potentially an electrical hazard to poll workers and voters.

Fig. 11 – Exposed 110 volt wiring and socket falling out

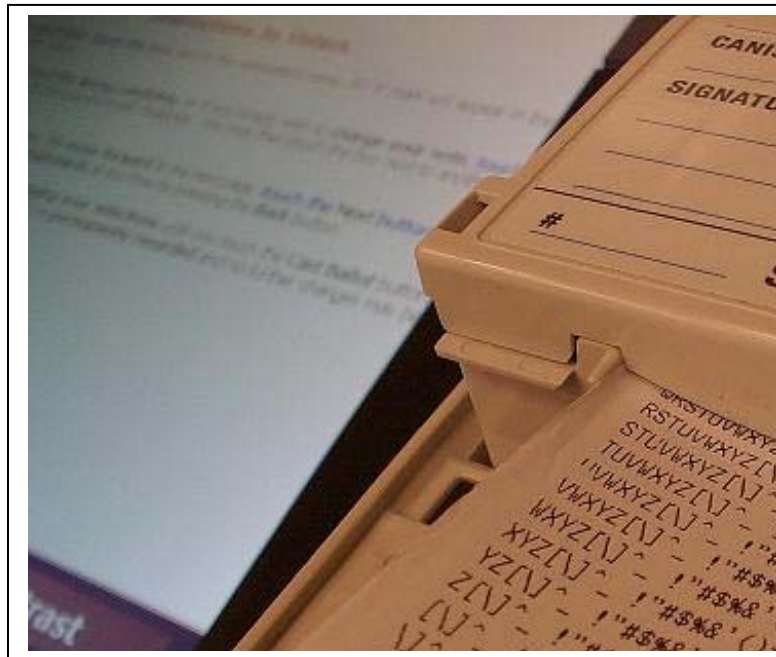
13. VVPAT – Voter Verifiable Paper Audit Trail: The printer mechanism for the TSx machines examined in Emery County does not sufficiently guide the paper, producing frequent paper jams.

Fig. 12 – Paper jam in progress

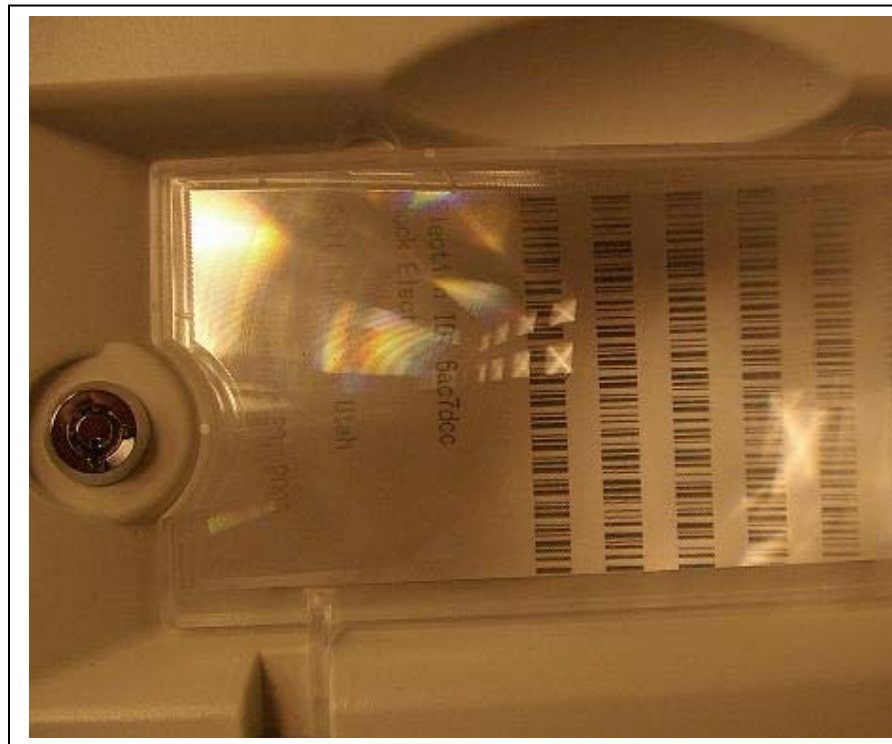
In addition, a design decision to place a brown door over the paper which the voter is supposed to verify leads to questions about the usefulness of the VVPAT. Unless the door is

lifted up it obstructs view of the paper representation of the voter's vote. If the system is to be used to verify a paper trail, it should have instructions printed prominently on the casing instructing voters to lift the brown door to see the paper trail.

Fig. 13 – Brown door blocking view
 of voter verifiable paper trail
